# safety bulletin

# ACAS issue update

# A summary of the Eurocontrol ACAS bulletin n.7

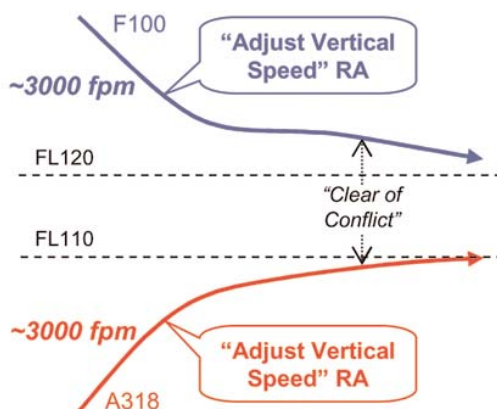
## Event 2: Level-off with 1000 ft separation

An A318 is climbing to FL110 at about 3000 fpm. A Fokker 100 is descending to FL120, also at about 3000 fpm.

The aircraft trajectories are converging both horizontally and vertically. Due to the high vertical closure rate (6000 fpm), the A318 and the F100 receive an "Adjust Vertical Speed" RA at respectively 900 and 1000 ft from their cleared flight level. Both RAs request to reduce the vertical speed to 1000 fpm.

- The A318's pilot reduces the rate of climb to less than 1000 fpm.
- The F100's pilot first stops the descent and then descends again at about 1000 fpm.

The correct reactions to the RAs by both pilots minimised the impact on ATC.

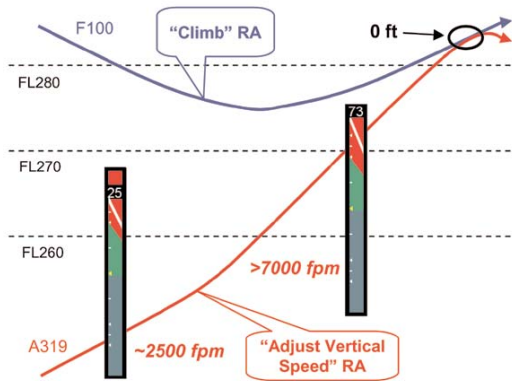
**Event 3: Wrong reaction to "Adjust Vertical Speed" RA**

An A319 is climbing to FL260 at about 2500 fpm.

When passing through FL251, it receives an "Adjust Vertical Speed" RA requiring a reduction in the rate of climb to 1000 fpm. The RA is triggered against a Fokker 100 descending to FL270 at 2000 fpm on a converging track.

The A319's flight crew misinterprets the RA and increases the rate of climb to more than 7000 fpm instead of reducing it. Due to this opposite reaction to the RA and despite a correct response of the Fokker 100 to the coordinated RAs ("Adjust Vertical Speed" then "Climb"), the A319 receives a strengthened "Descend" RA. However, the flight crew continues to climb very quickly until the "Clear of Conflict".

As a result, the A319 busts its cleared flight level by 2200 ft and the aircraft passed at a distance of 1.6 NM at the same altitude.

The safety issue of opposite reactions to "Adjust Vertical Speed" RAs whereby pilots believe that they are reacting appropriately was described in detail in the **ACAS Bulletin n°3**. The event above illustrates that such events continue to occur. Due to the severity of this issue, there are several on-going actions to address it, including pilot's training and TCAS II specifications.

- Some airlines have adapted their TCAS II training programmes with respect to this issue. The main objective is to explain clearly to pilots that when an "Adjust Vertical Speed" RA is triggered by TCAS II, the required action is always to **REDUCE VERTICAL SPEED**. This enhanced training has contributed in the reduction of the number of occurrences but has not fully eradicated the problem.
- RTCA, the TCAS II standardisation body, is investigating this safety issue and the causes for such opposite reactions have been identified in a recently published report. The work is going on to improve the aural message and the display for these specific RAs. EUROCONTROL, in support of RTCA work, is investigating a possible modification of the "Adjust Vertical Speed, Adjust" aural annunciation, together with a simplification of the TCAS II RA list.

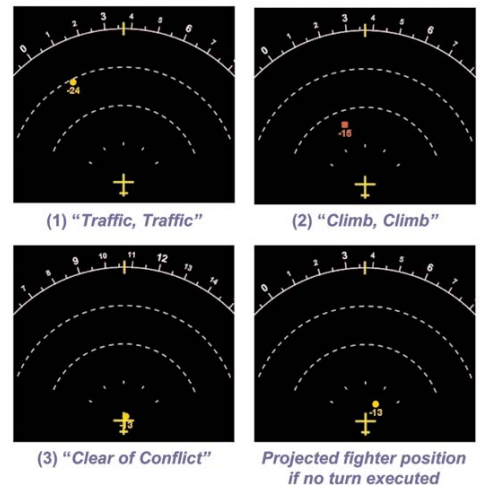
**Event 4: Inappropriate turn based on TCAS traffic display**

A Fokker 100 is descending to FL110. Its TCAS triggers a "Traffic Advisory" and then a "Climb" RA when passing a fighter at FL130, against a fighter at FL115. The pilot correctly follows the RA and starts to climb.

However, the pilot also initiates a 70-degree right turn based on the TCAS traffic display which shows the intruder on the left. The climb provides a safe vertical separation (more than 1000 ft) whereas the right turn actually reduces the horizontal separation from 1 NM to 0.3 NM.

Due to the relative motion of the symbol and the lack of speed vector on the TCAS traffic display, the flight crew incorrectly interpreted that the intruder was converging towards the own aircraft from the left under a bearing of 30°. However, the ground track angle was about 90° as shown on the figure.

Therefore, pilots must only use it according to its intended function: to assist the visual acquisition of surrounding aircraft.

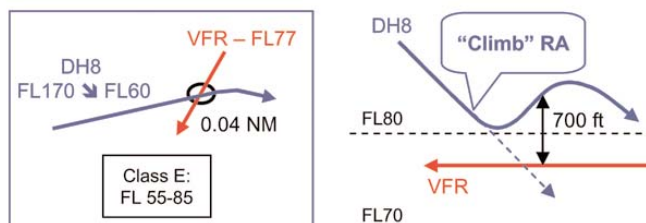
### Event 5: Necessary RA against VFR aircraft

A DH8, flying IFR, is descending to FL60. When approaching FL80, it receives a "Climb" RA. The pilot stops the descent and climbs back about 400 ft. The intruder is an uncontrolled altitude transponding VFR aircraft cruising at FL77.

The VFR was flying in class E TMA in radio contact with FIS. The vertical limits of this class E airspace range from FL55 to FL85.

The pilot's reaction to the "Climb" RA enabled the DH8 to pass 700 ft above the VFR. Simulations indicate that without TCAS, the minimum separation between the aircraft would have only been less than 150 ft and 0.04 NM.

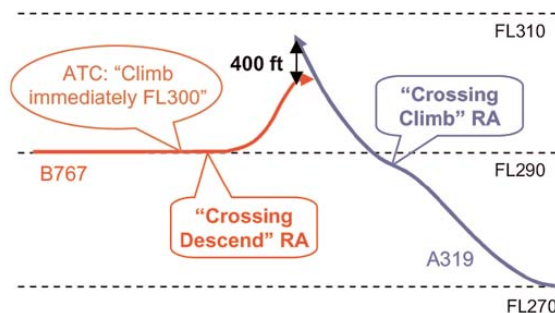
### Event 6: Opposite manoeuvre to RA to follow ATC avoiding instruction

A B767 is maintaining FL290 heading West. An A319, heading South-East, is at FL270 on a converging track. The aircraft are controlled by two different ATC units (the vertical boundary is FL285).

The A319's pilot requests for a higher cruising level. Due to a coordination error between the two ATC units, the A319 is cleared to climb to FL290 with the B767 whilst in conflict.

Following Short Term Conflict Alerts triggered in both ATC units, the B767 is instructed to climb immediately to FL300 and the A319 to "expedite descend FL270".

However, almost at the same time, each aircraft receives a coordinated RA opposite to the ATC instruction.

- The B767 receives a "Crossing Descend" RA. The pilot disregards the RA and follows the ATC instruction to climb.
- The A319 receives a "Crossing Climb" RA. The pilot correctly reacts to the RA by increasing the rate of climb.

Because of the B767 pilot's opposite manoeuvre to the RA, the very small vertical separation between the aircraft does not increase. Consequently, the A319 receives an "Increase Climb" RA and the pilot increases the rate of climb to 5000 fpm. The B767's pilot eventually recognises the "Descend" RA and stops the climb just before the "Clear of Conflict".

Despite the large vertical deviation of the A319 (3000 ft), the aircraft passed at 400 ft and 0.3 NM.

**"Pilots shall respond immediately by following the RA as indicated, unless doing so would jeopardise the safety of the aeroplane"**

**"Pilots shall not manoeuvre in the opposite sense of an RA"**

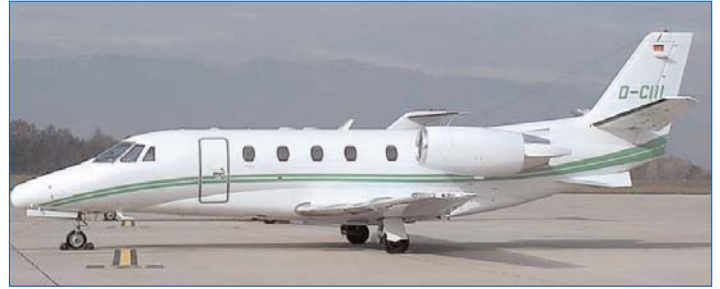
The second case happened early in the morning. A Cessna 56X was cleared to taxi into the holding bay Zulu for a departure on runway 05. As it was doing so, the crew were

instructed to hold short of the runway and were asked if they could accept a departure from the intersection, which they acknowledged. The C56X entered the runway while another aircraft was rolling for take-off on runway 23. The ATCO immediately instructed the C56X to hold position and subsequently cancelled the other aircraft's take-off clearance. In its report, the crew reported being busy performing a second series of standard thrust reverse checks as they had received a faulty indication during the first one and were preoccupied with troubleshooting this indication.

Another factor that may have had an influence on the course of events is the taxiway and holding bay Zulu layout and marking.

The CAT I stop bar is painted approximately 90 m from the runway center line and equipped with wig-wag lights either side. There are also two lighted panels indicating the runway that comply with the standards fixed by ICAO Annex 14. The

CAT II line is right at the entrance of taxiway Zulu (as shown on picture). However, keep in mind, that markings on airport grounds are the same as the ones on the streets and their visibility is not as good at night

and/or in rainy conditions as it is during the day. Obviously, for these two cases, the markings were not distinct enough to prevent both aircraft from entering the runway.

**On skyguide's side:** SAMAX (Swiss Airport Movement Area Control System) has a built-in tool called RIMCAS which has not yet been tuned for its purpose in Geneva. This tool should normally be implemented in the first trimester of 2008. The tool will monitor the target position reports and assess the traffic situation. Once a potentially hazardous situation is detected, an alert message is sent to the CWP's (Controller Working Positions) where a visual and audible warning are given to the air traffic controller. It is designed with different parameters that apply to the runway, the taxiways and stop bars. It functions with the indications received from the transponders. All aircraft are equipped, as well as the vehicles that, for various duties, are entitled to enter the runway.

**On the airport's side:** The CAT II stop bar that is at the entrance of the taxiway Zulu (see picture) will be relocated halfway through the Zulu holding bay and fitted with red lights that will be also be operational in CAT I conditions. This lighting development is scheduled to take place this year. In addition, the study for the renewal of the complete lighting system of the AIG has been launched. The whole process will take some time, but it is promising and might improve the situation further.

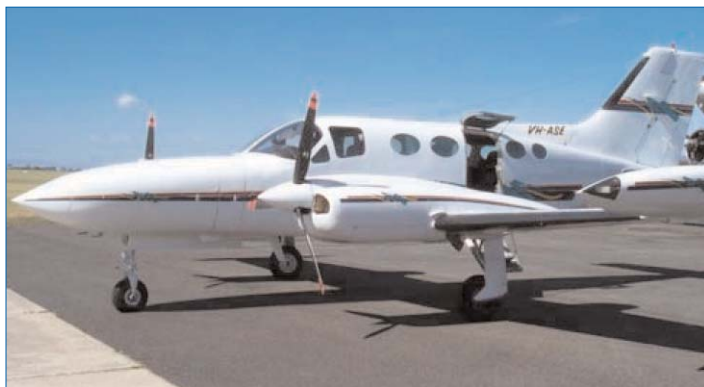
Cessna 421

The first case took place on a winter evening when a Cessna 421, which had been instructed to taxi into the holding bay Zulu, crossed the CAT I stop bar (see picture). When the ATCO asked the crew if they were on the runway, they reported entering it. They were then instructed to vacate via taxiway Echo as an inbound aircraft had passed 2 NM final. As the landing aircraft passed the threshold, the C421 was reaching the CAT I line on taxiway Echo. The pilot stated in his report that it was due to a loss of situational awareness.
