safety bulletin

Another update on the Honeywell transponder issue

One Romeo

Density 0.79

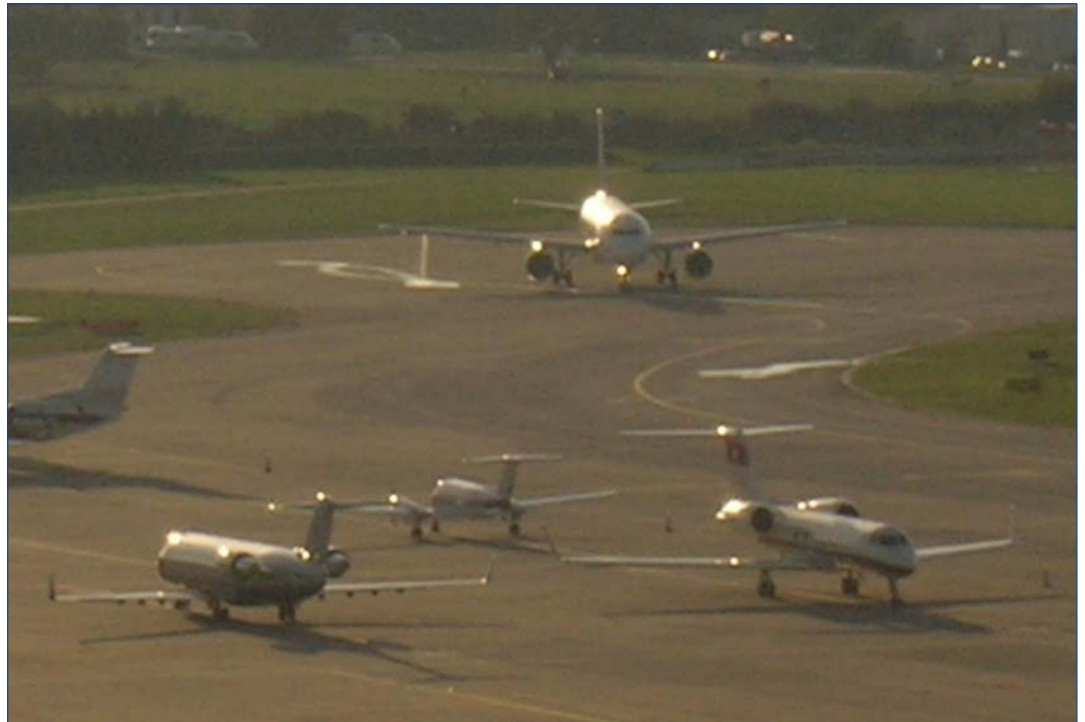
Picture 1

From the tower, we could see the fuel coming out below the right wing of the Airbus 321 (see picture 1). ADC(**) controller instructed the crew to shut down the engines and

SSA(*) was alerted, holding bay 05 was closed but flight operations were still going on. Departing aircraft were taxiing up to Foxtrot taxiway to enter runway 05.

to remain at its present position in order to wait for the fire brigade. The operations were directed by the SSA captain, in close cooperation with the Tower and the AIG(***)

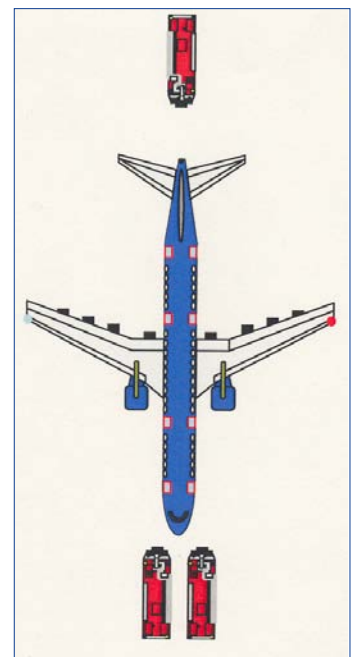
Picture 2

deployed themselves into a position called «India» around the aircraft (see picture 2). This means, vehicles in front and behind of the aircraft. The fire brigade captain decided to spread a foam carpet not just underneath the right wing but underneath the whole aircraft as the kerosene was slightly drifting below the Airbus to reach the other side of

the aircraft due to the slight slope of the holding bay 05. He then boarded the Airbus 321 to ask a few questions to the crew.

On board ,132 passengers, one baby and 6 crews were waiting. The fire brigade decided to unload them via a ladder. The crew became worried about this unloading because of the slippery foam carpet which could be dangerous, according them, but that was SSA's decision and they had no choice (SSA says that it is not that slippery). The evacuation was done in a very calm way and everybody was taken back to the airport via buses by an handling company which took care of the passengers and later also towed the aircraft into position 85.

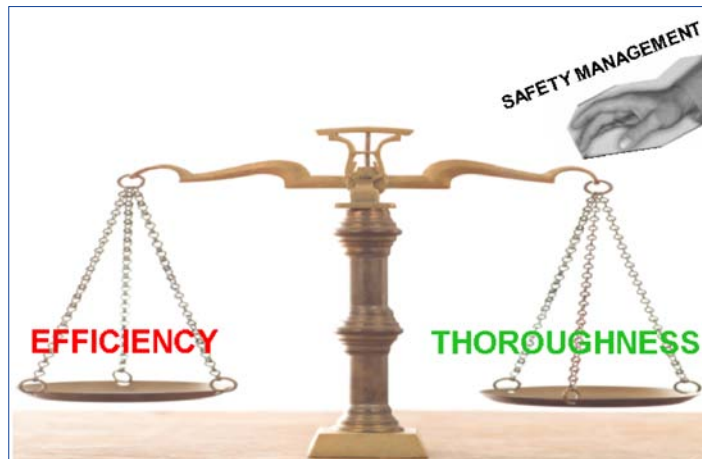
This ETTO (efficiency thoroughness trade-off) seems to be a common feature of human performance that appears to play a role on the level of individuals and on the level of organizations alike. See the graph beside to have an idea of the typical ETTO manifestations on individual and organizational levels. These definitions are taken directly from the book of Erik Hollnagel (Barriers and Accident Prevention, 2004) but the question you can ask yourselves is whether you think these rules are applicable to your world or not?

Typical Individual ETTOs

- Looks OK
- Not really important
- It will be checked by someone else later
- It has been checked by someone else earlier
- Cannot remember how to do it
- It worked the last time

Typical organizational ETTOs

- Negative reporting (lack of information is interpreted as confirmation that everything is safe)
- Management double standards (typically the official policy puts safety first, but in practice people know that efficiency is more important)
