safety bulletin

Safety Assessment VISTA

Loss of tracks in the South of the Alps and transponder anomalies

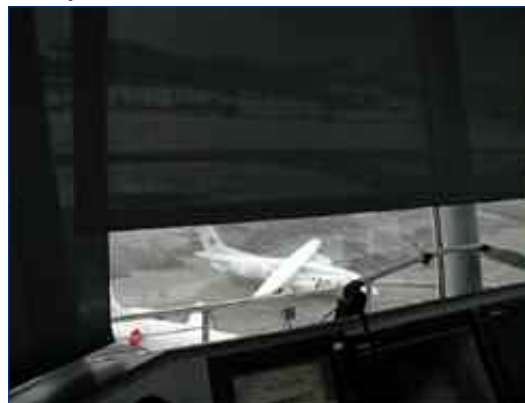
Pic 1 –before

From around 2 o'clock in the afternoon until sunset all the blinds facing in a SW direction have to be lowered almost completely in order not to be blinded by the sun. As luck would have it, our RWY's and the main traffic patterns are also on the west side of the TWR. Consequently, during the period of sunshine, from a window 3.5m high we are left with a slit of 30cm. (pic 1)

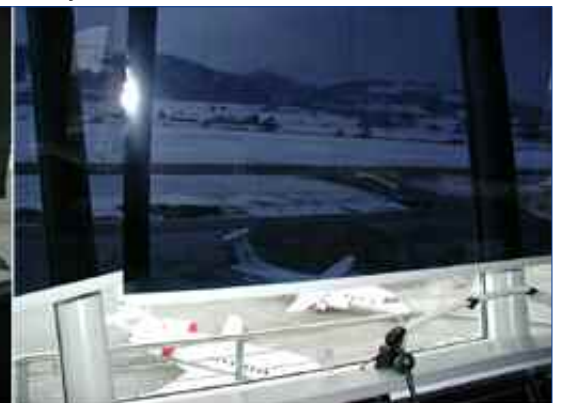
Pic 2 –after

January 2005 the new equipment was installed and I am sure that it will increase safety as well as comfort.

Among the solutions I mentioned a see-thru-shade which I found in the Internet and which was advertised with «**FAA mandatory safety equipment, installed in more than 150 TWRs worldwide**», what an argument for a SIR and some of you can probably imagine the smile on my face...

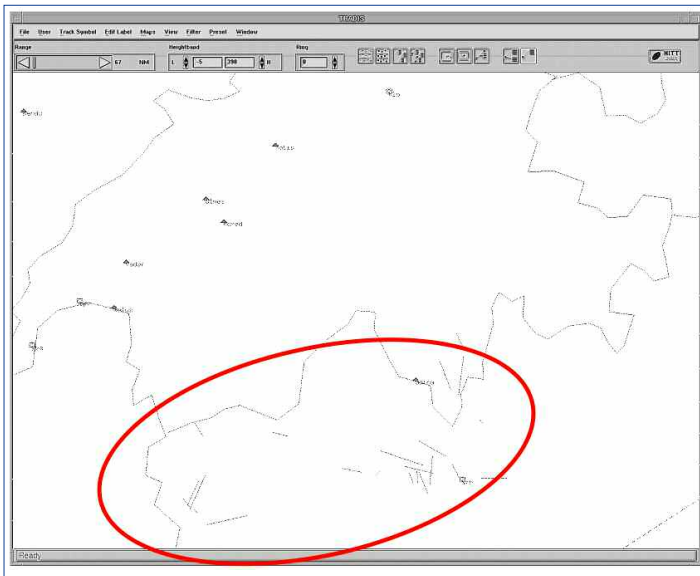
In the last few years, a series of radar tracks losses from the controllers' screens has been reported in the area South of the Alps, over Italy but within the skyguide controlled airspace. These track drops are caused by a simultaneous loss of detection from all (secondary) radars, in general for a duration of 30 seconds up to 2 minutes.

Figure 1 - segments representing cases of track drops, within the affected area

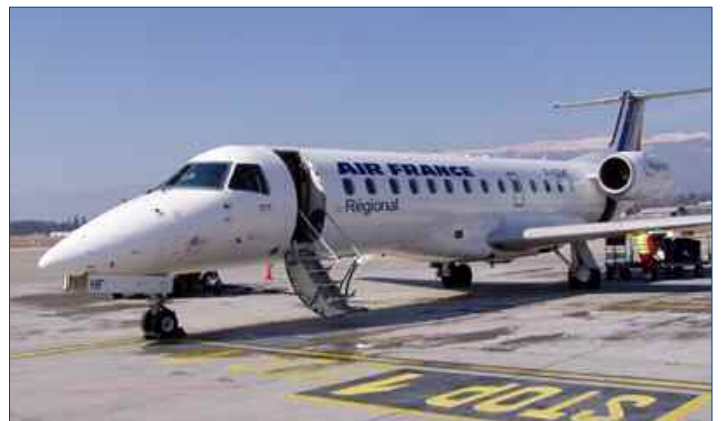
Figure 2 - Embraer ERJ, parked on stand in Geneva

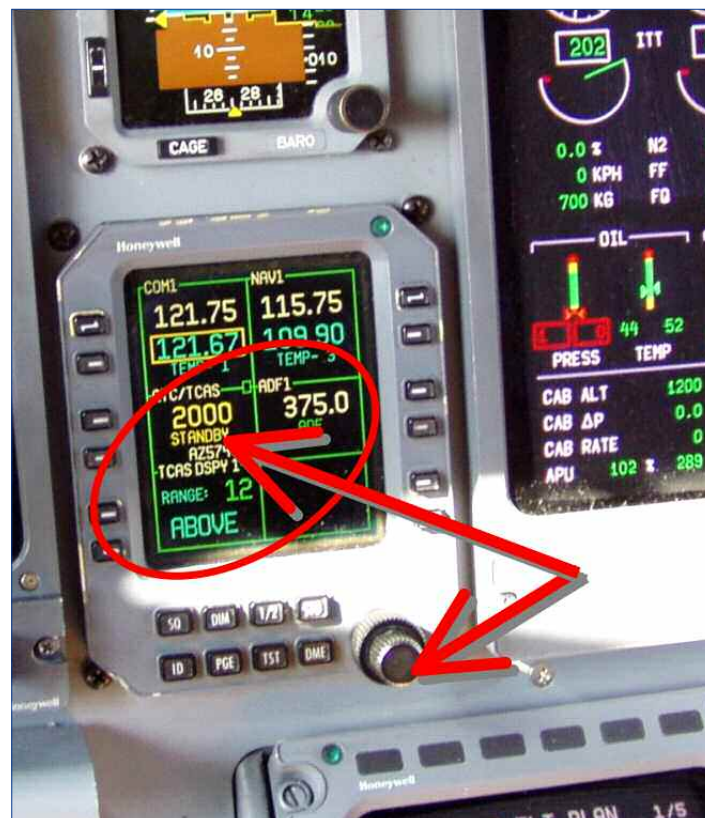
As a final proof, a recent technical bulletin from the transponder manufacturer informed that certain models revert spontaneously into «STAND-BY» mode, if the code selection, using the turning knob, takes more than 5 seconds.

The consequence is that the transponder becomes inoperative not only to radar interrogations, but also to TCAS.

Figure 4 - Detailed view of the transponder code and mode, and the selecting knob

To restore the expected operation, the pilots shall then re-select manually the right mode. In several cases, this action was executed only after ATC controllers reported a «radar contact lost», which retained crews' attention to the transponder mode.

Since the situation proved to be unsafe and unsatisfactory, the first immediate mitigation was to ask the different companies to inform and keep their pilots particularly aware of the transponder mode, after a code change. Some of them quickly established operational procedures for their crews.

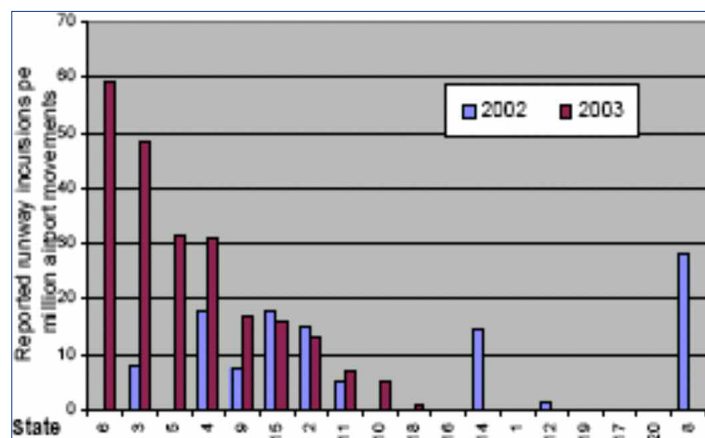
Another example is given in this report. «Reporting rates are also variable over time. One State reported 1 runway incursion in 2002 and 120 in 2003. This indicates a growing awareness of underlying issues, which is to be welcomed. However, it is impossible to identify ATM safety trends on the basis of such variable information.»

Figure 2: Runway incursion reporting rates
