# safety bulletin

# ACAS issue update

# A summary of the Eurocontrol ACAS bulletin n.7

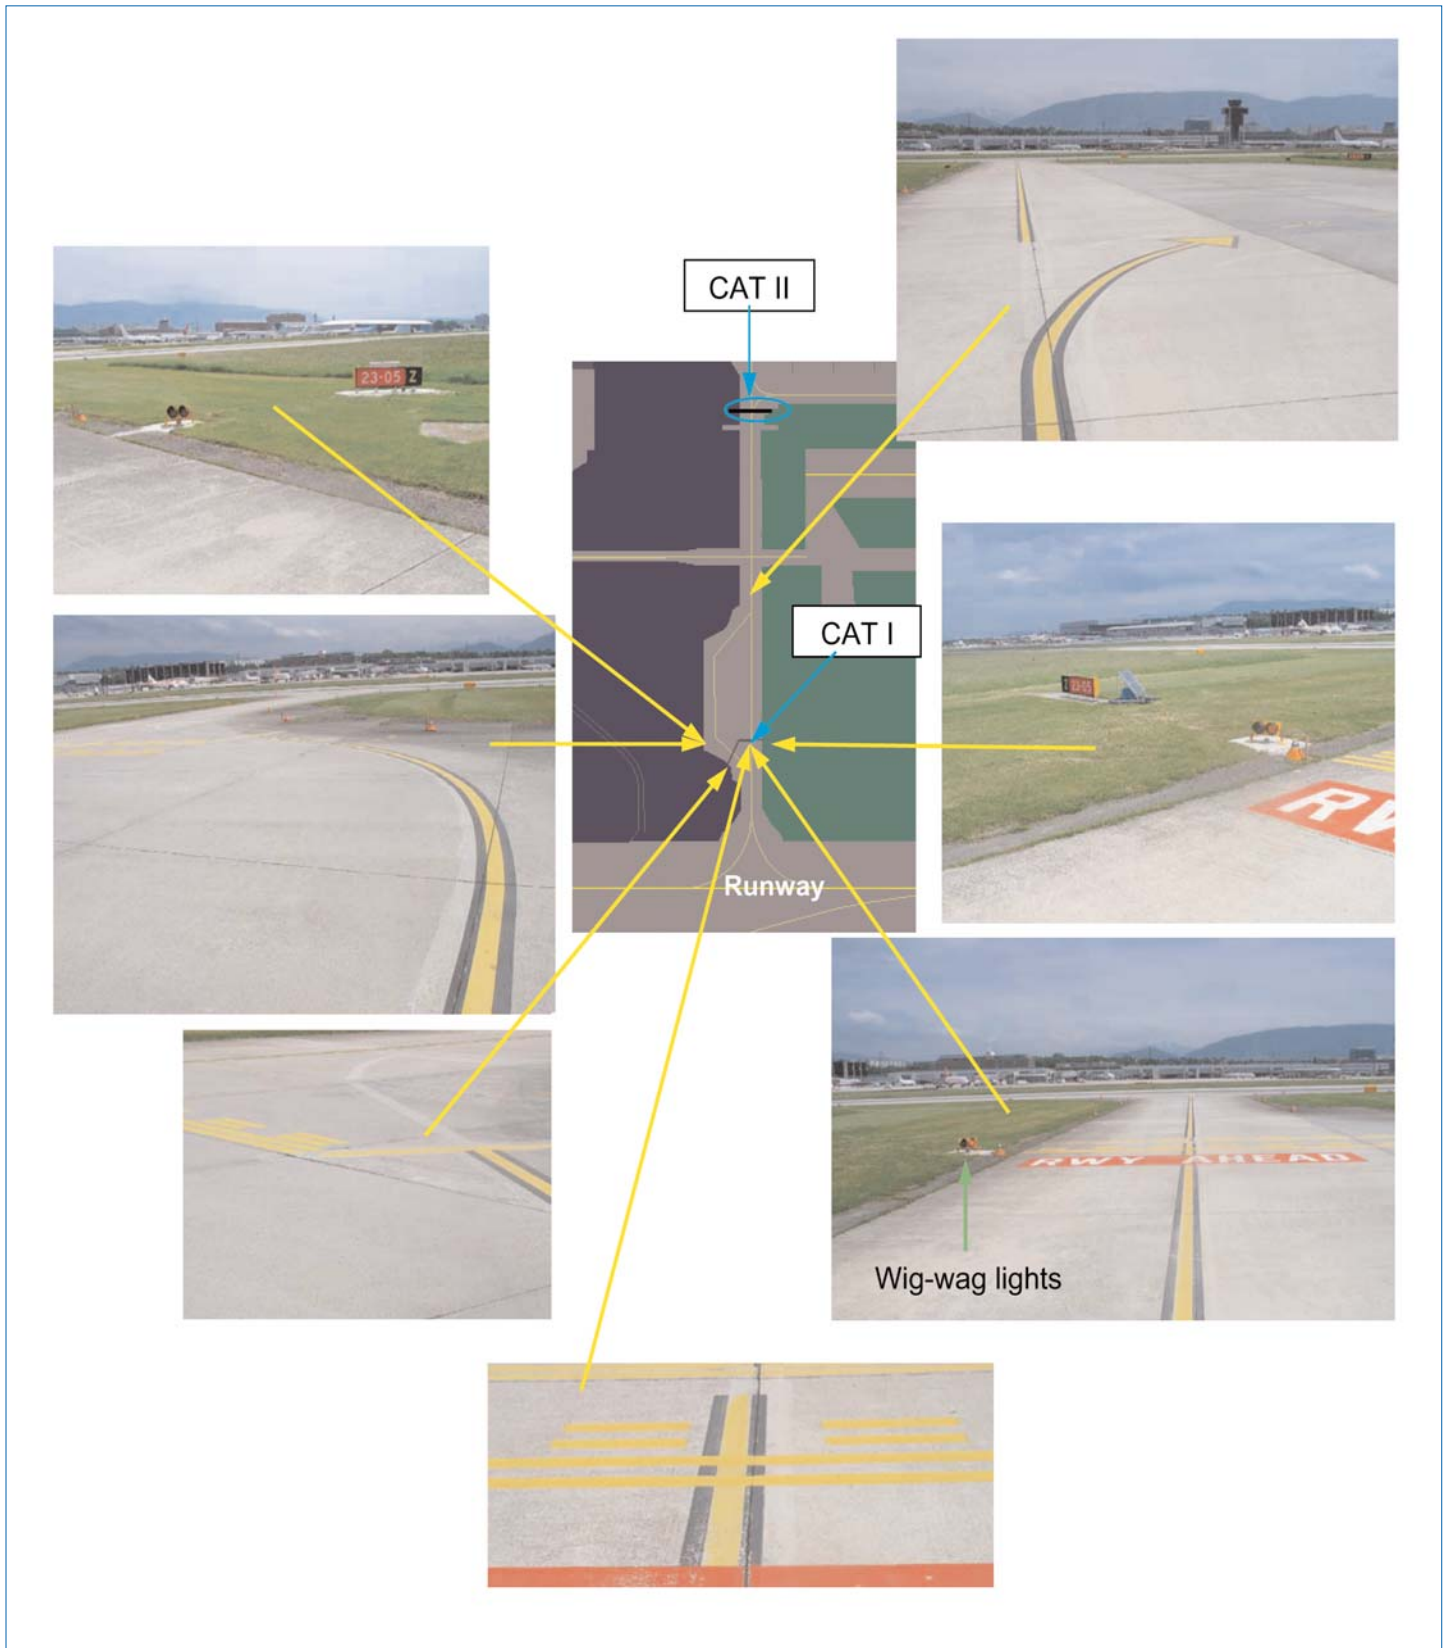
► Rwy ahead

and/or in rainy conditions as it is during the day. Obviously, for these two cases, the markings were not distinct enough to prevent both aircraft from entering the runway.

**On the airport's side:** The CAT II stop bar that is at the entrance of the taxiway Zulu (see picture) will be relocated halfway through the Zulu holding bay and fitted with red lights that will be also be operational in CAT I conditions. This lighting development is scheduled to take place this year. In addition, the study for the renewal of the complete lighting system of the AIG has been launched. The whole process will take some time, but it is promising and might improve the situation further.

**On skyguide's side:** SAMAX (Swiss Airport Movement Area Control System) has a built-in tool called RIMCAS which has not yet been tuned for its purpose in Geneva. This tool should normally be implemented in the first trimester of 2008. The tool will monitor the target position reports and assess the traffic situation. Once a potentially hazardous situation is detected, an alert message is sent to the CWP's (Controller Working Positions) where a visual and audible warning are given to the air traffic controller. It is designed with different parameters that apply to the runway, the taxiways and stop bars. It functions with the indications received from the transponders. All aircraft are equipped, as well as the vehicles that, for various duties, are entitled to enter the runway.

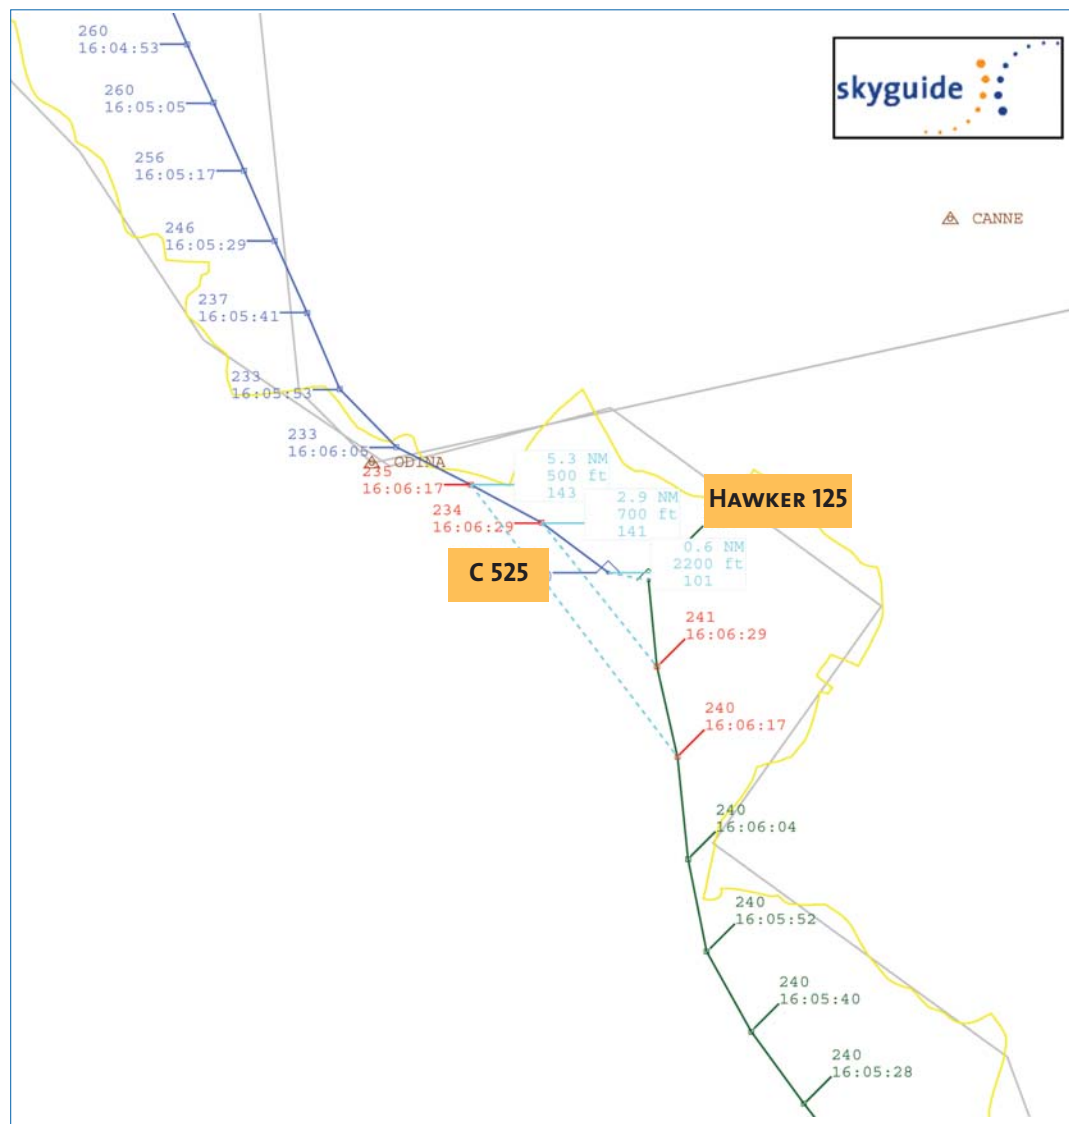
► bizjet «Citation 525»...

A periodically stuck R/T transmitter combined with CB activity and several internal and external sector-interfaces, lead to a highly complex situation. Human – human coordination breakdown, where the closed

loop between clearance and read-back was interrupted, led to goal conflicts of achieving the coordinated exit FL versus maintaining vertical separation given the uncertainty of the R/T communication. This led to forced changes in concepts. The discrepancy of at least 12 seconds between the actual traffic situation and the MRT presentation may have hampered the monitoring of activities in a «tight» situation leading to difficulties in finding the adequate application of avoiding actions. Furthermore the fact that the con-

mention the combination with an interface to an adjacent center. Some strategies to cope with similar situations are outlined in the ATMM CH (chapter 15.4 Use of EM-channel 121.5, chapter 20.2 Blocked Frequency, chapter 20.4 alternative means of COM) and in the emergency manual chapter 3.7 Radio Failure.
